**MERRIMACK RIVER BASIN  
ASHLAND, NEW HAMPSHIRE**

**SQUAM LAKE DAM  
NH 00059**

**PHASE I INSPECTION REPORT  
NATIONAL DAM INSPECTION PROGRAM**

**OCTOBER 1978**

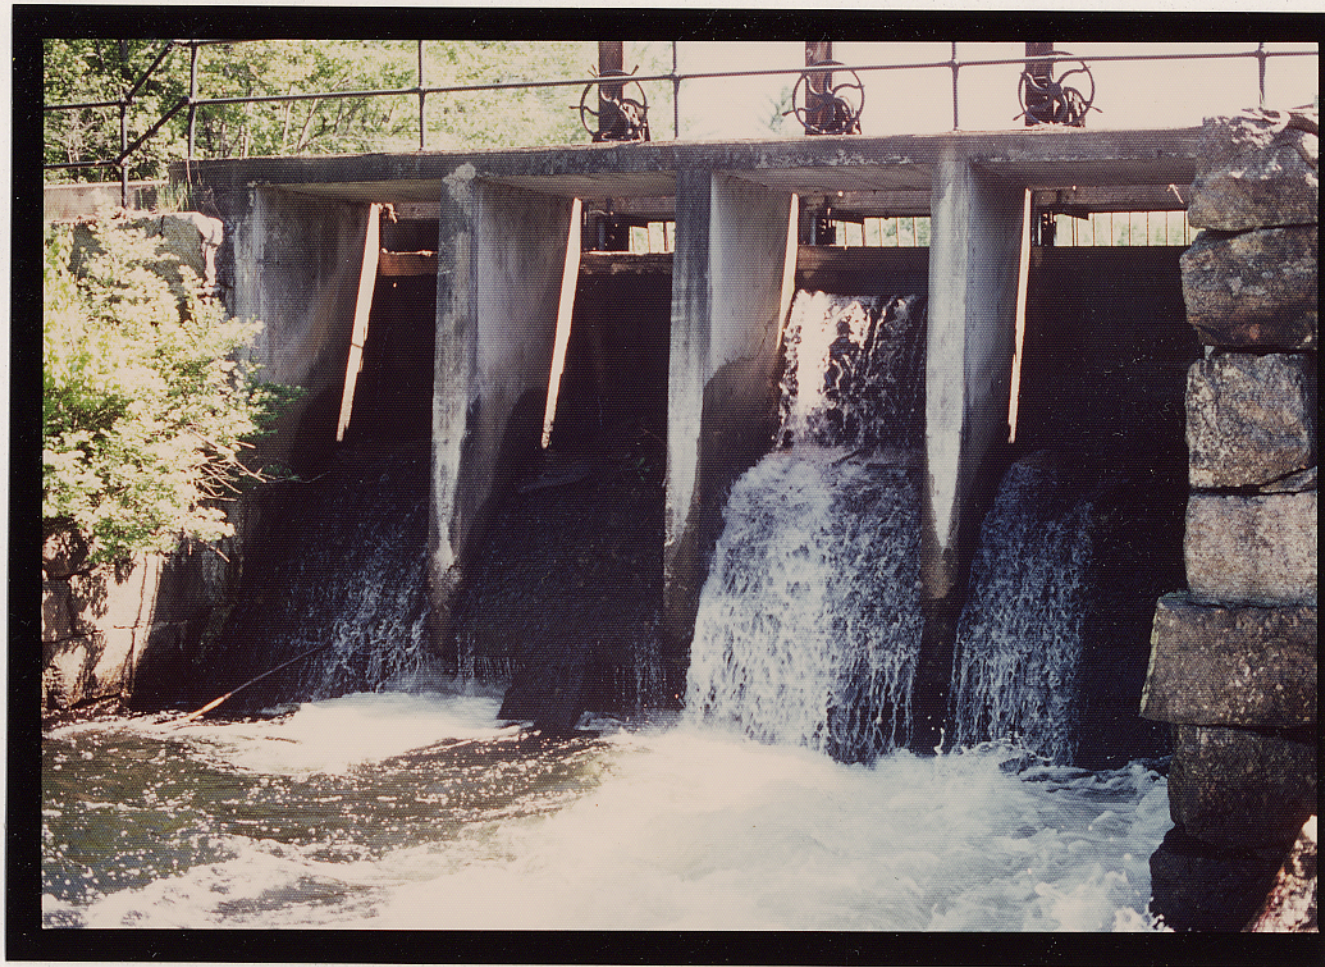
View of the spillway section showing the permanent concrete weir and the stop planks surmounting the ogee crest. The low level outlets are submerged below the tailwater level directly beneath one of the three visible piers. Stone works on right of picture dates back to original construction in 1856.

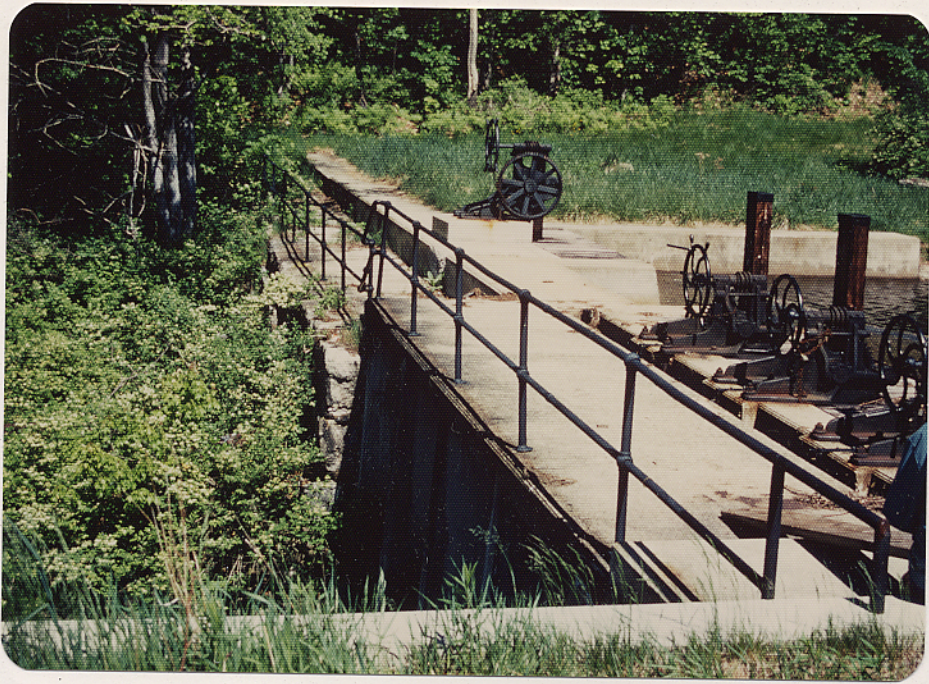
Photo 1 - View of the dam taken from the left abutment, looking toward the right abutment. The spillway section is in the foreground, showing the sluice gate hoists and the stems of sluice gates. The right abutment non-overflow section is in the foreground.

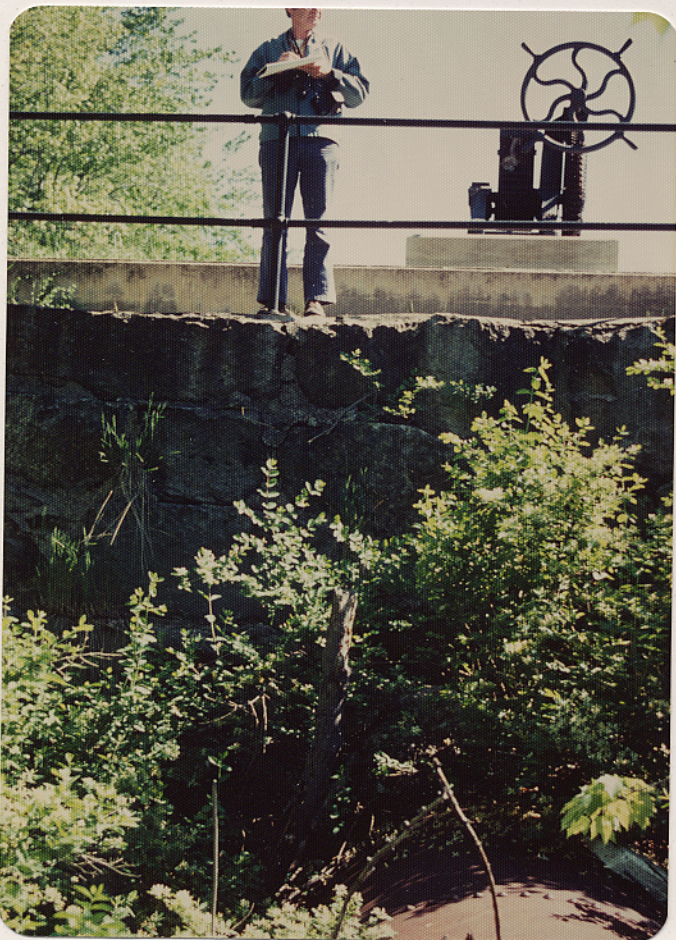
(2) 66-inch Diameter Penstock through the Right Non-overflow Section of the Dam. This abandoned and cutoff penstock at one time led to a mill situated immediately downstream of the dam. On the upstream face of the dam, a manually operated sluice gate seals the entrance to the penstock. This gate is no longer used and is simply left in the closed position. There was no discernible leakage coming from the open end of the penstock. This gate should either be repaired as necessary for use as an additional low level outlet or dismantled and the penstock permanently sealed. Plans for permanently sealing this penstock are in the files of the NH-WRB, but as far as could be determined, this modification was not carried out.

Photo 2 - View of the right abutment non-overflow section from downstream. The original masonry wall is visible in front and the new concrete parapet wall is in the background. The 66-in. diameter abandoned penstock and its gate hoist are visible at the picture's right.

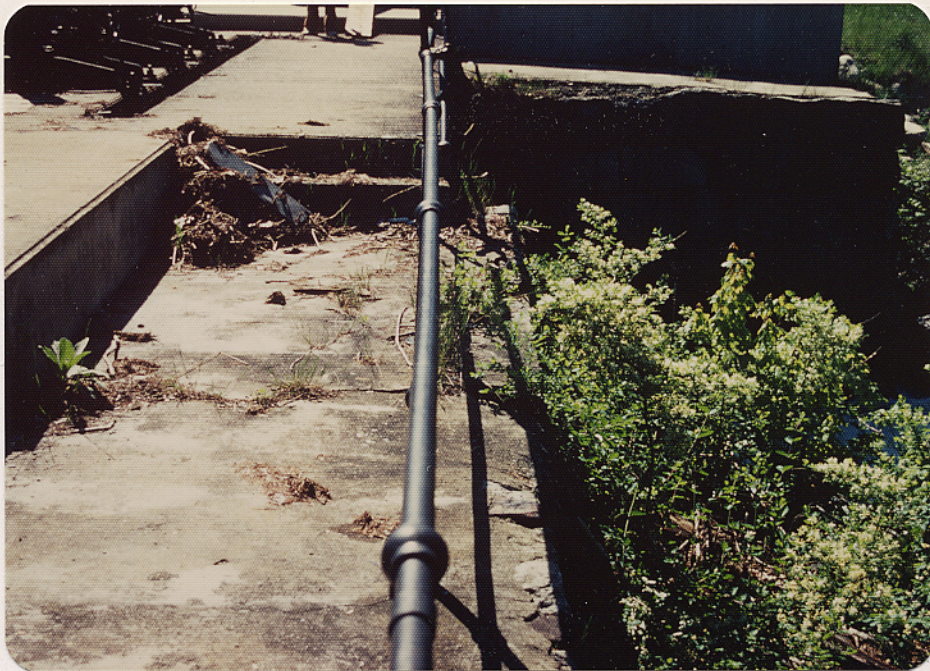
Photo 3 - View of the dam from the right abutment showing old and new non-overflow sections and the relation to the spillway walkway elevation.

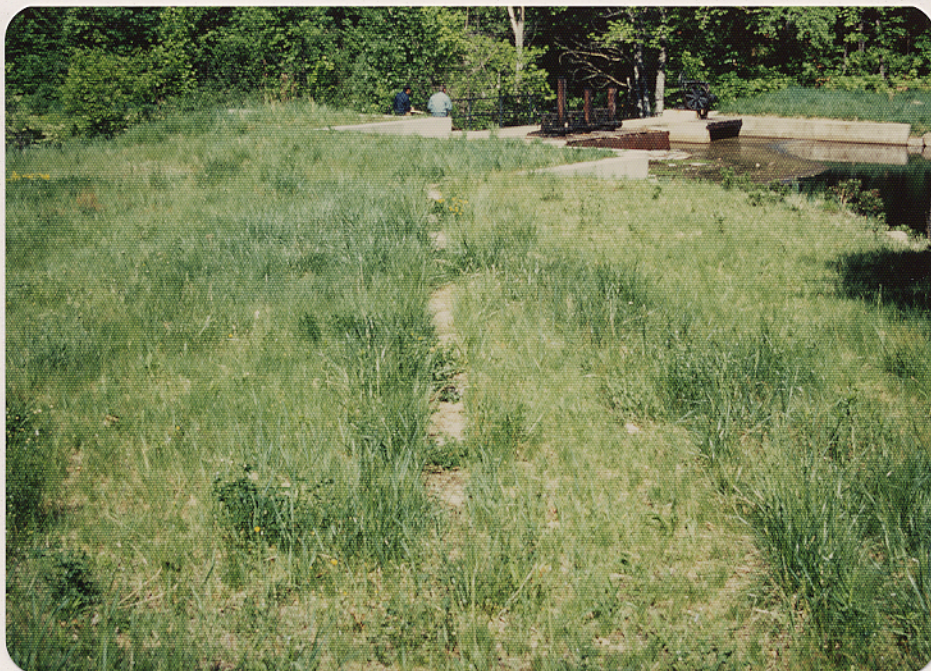
The sink hole leak reported in 1968 has apparently been remedied by the reconstruction. The specific actions taken were to concrete face the masonry on the reservoir side of the abutment wall and adding fill on the downstream side of the parapet wall.

Photo 4 - View of the dam from the left abutment looking along the line of the cutoff wall which is visible in the foreground. The cutoff wall has been backfilled on the downstream side.

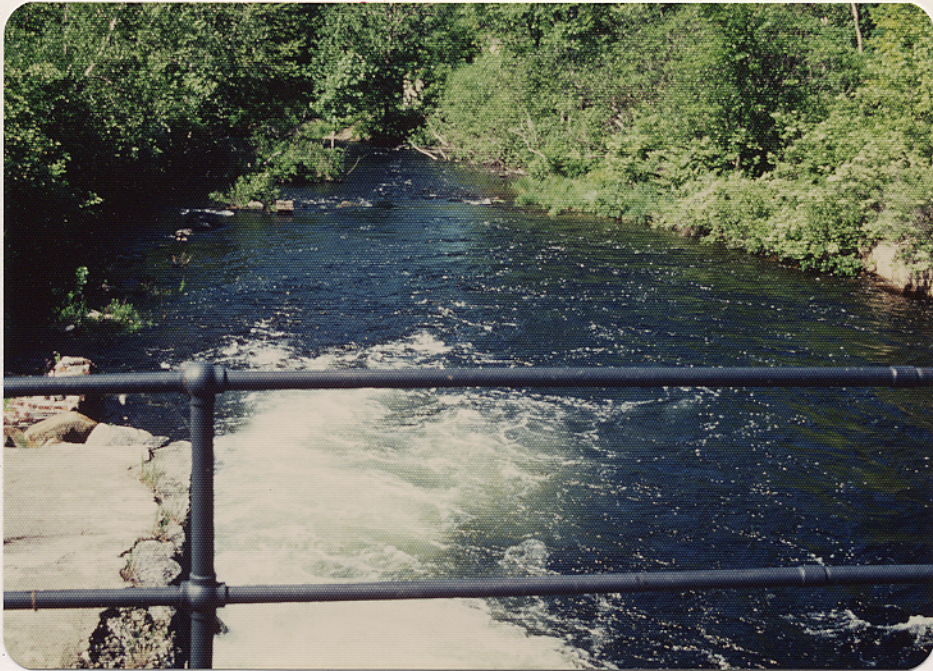
Photo 5 - View of the downstream channel of Squam River taken from the dam.

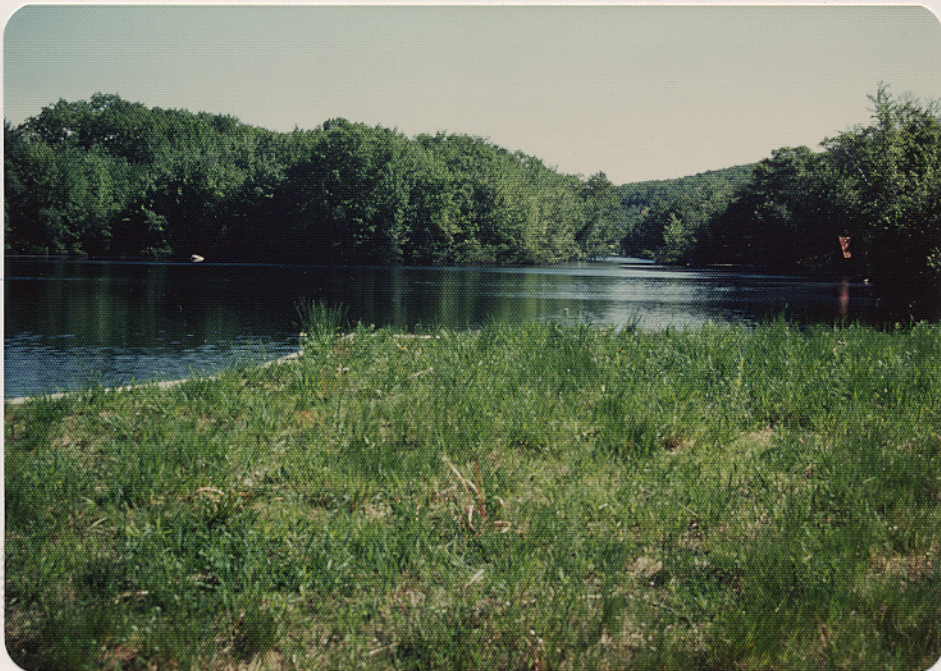
Photo 6 - View of the approach channel section of Squam Lake.
